## **Quesnel River Research Centre (QRRC) Newsletter December 2020**

The Quesnel River Research Centre (QRRC) is part of the University of Northern British Columbia (UNBC) and is located near Likely, British Columbia. Since 2007 the QRRC has had an annual Open House in early fall where researchers have presented findings to the local community. Given COVID-19, there was not an Open House in fall 2020. This newsletter describes some of the research activities being undertaken at the QRRC and in the Quesnel watershed since fall 2019.

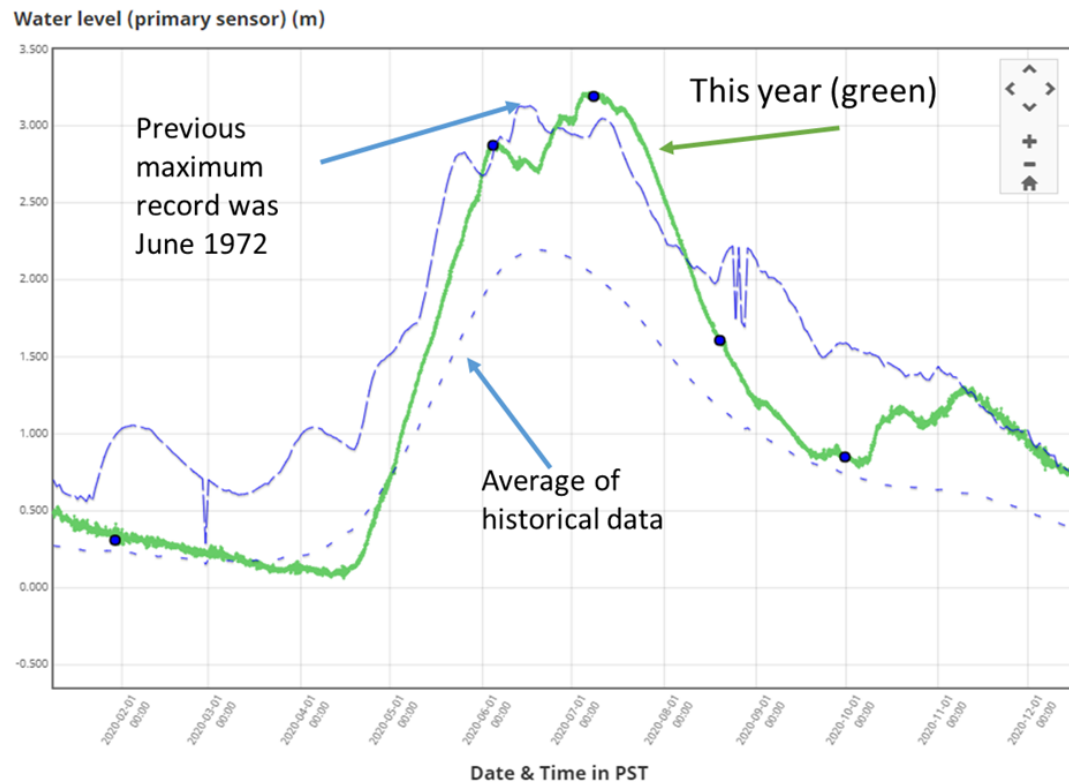
Figure 1. The surface water level of Quesnel Lake in 2020 compared to the historic average (source: Northern Hydrometeorology Group, UNBC).

An unusually deep snowpack in the watershed caused high river flows in the spring which caused high water levels in Quesnel Lake, especially in July when the lake reached a record level; the previous maximum was in June 1972 (Figure 1). This caused problems for several of meteorological stations and some interesting challenges for the research group in terms of maintenance (Figure 2). However, the meteorological stations performed well and provided further data for 2020. Some preliminary findings, based on data from 2016 to 2018, are presented in a paper by former UNBC MSc student Hadleigh Thompson (Thompson et al. 2020) in the *International Journal of Climatology*.

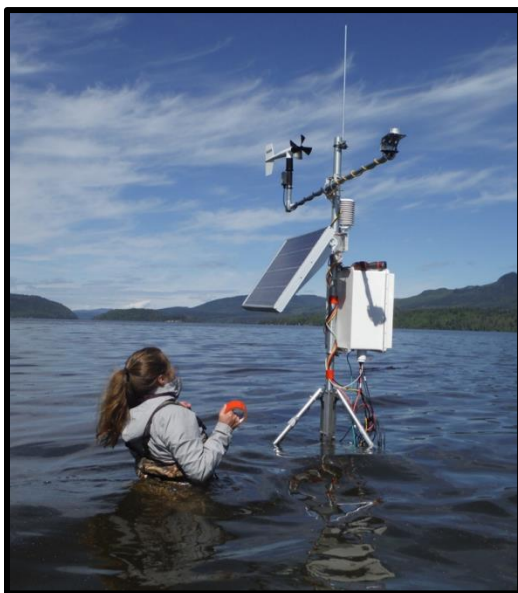
Figure 2. Servicing one of several meteorological stations in the Quesnel watershed (photo: Northern Hydrometeorology Group, UNBC).

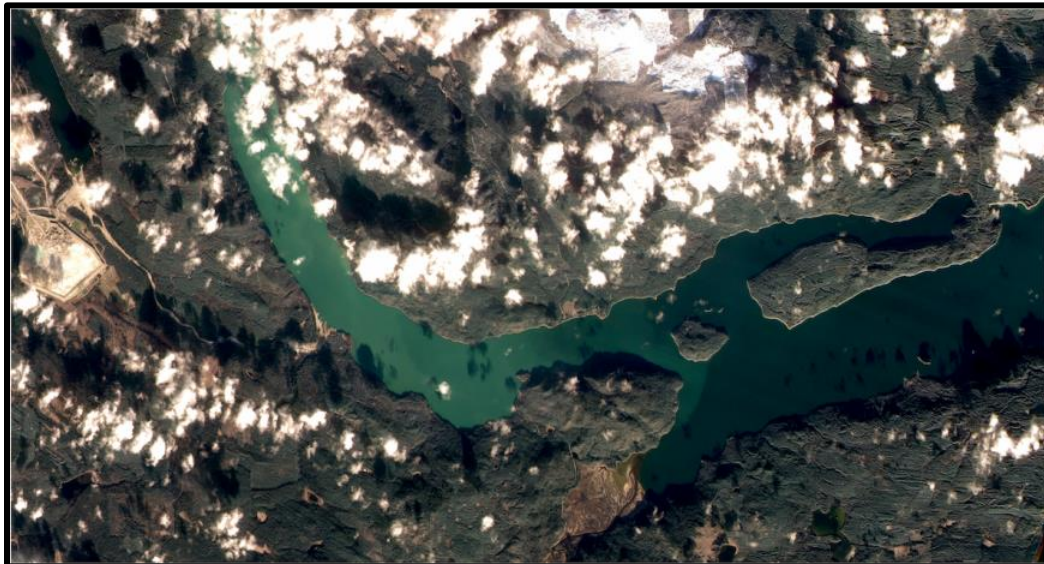
Figure 3. The entire West Basin of Quesnel Lake turned bright green following the Mount Polley mine (far left) tailings spill when contaminants previously trapped below the thermocline were mixed to the surface during 2014 autumn turnover, three months after the spill. (Image source: FormoSat2; from Hamilton et al. 2020)

As the lake mixed from top to bottom (called turnover) in autumn 2014, the contaminated deep water was brought to the surface, abruptly changing the colour of the clear blue lake to an abnormal bright green — a change first reported by residents of the lake. Using satellite imagery, we show for the first time the full spatial extent of this 2014 ‘greening’ event (Figure 3). Although the turbidity and green colour of the lake decreased over winter 2014/15, our water column measurements show that the turbidity of the lake increased during each subsequent spring and autumn turnover through 2017. One apparent source of seasonally elevated turbidity is resuspension of spill-related material off the bottom of the West Basin driven by basin-scale wave oscillations. This seasonal mobilization of spill waste is undesirable, as it potentially prolongs the exposure of aquatic ecosystems to contaminants. The ongoing discharge of excess mine waste water with high dissolved solid concentrations into the deep water of the West Basin via twin, multi-port diffusers represents an additional pollutant load which complicates our understanding of long-term impact of the spill. Research is underway to further investigate the seasonal turbidity signal and the ongoing discharge.

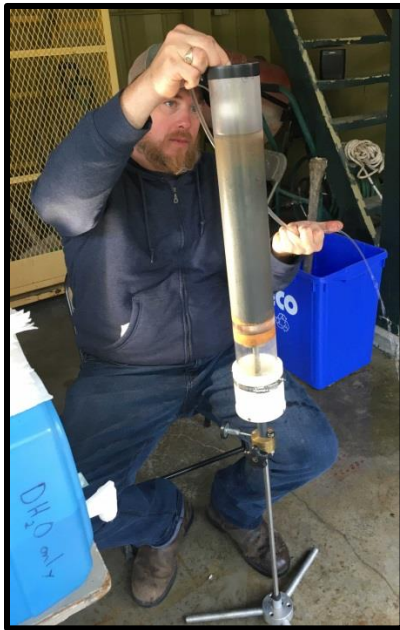
Figure 4. Dan Selbie removes excess water from a gravity core retrieved from Quesnel Lake before sectioning the core into slices for analysis of chemicals and other properties (photo: Ellen Petticrew).

A collaborative effort between Dan Selbie (Department of Fisheries and Oceans: Cultus Lake Laboratory) and Ellen Petticrew (UNBC, QRRC) to collect gravity cores from Quesnel and Polley Lakes was undertaken between September 16<sup>th</sup> to 21<sup>st</sup> 2020. Fifteen sediment cores were collected from six sites on Quesnel Lake and three sites in Polley Lakes using a “Super Glew” gravity corer (Figure 4). The core slices will be dated and analysed for a range of variables including organic matter content, metal concentrations and some paleolimnological parameters. The top 5 cm of each core was also subsampled for bacterial composition and quantity which will be completed in Sue Baldwin’s (UBC) lab. Several of the sites were located in positions cored in 2016 with a slo-corer (Hatam et al. 2019) and will be useful to allow a comparison of sediment change over the past four years.

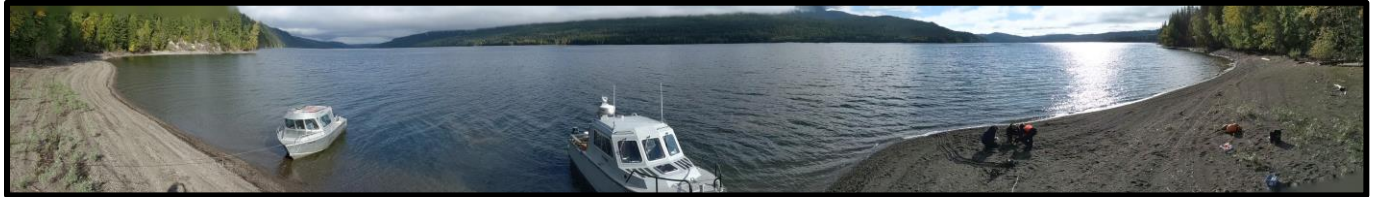
Figure 5. Mathews (QRRC) and Hutchison (DFO) at shoreline in Quesnel Lake while researchers prepare moorings (photo: Jordan Lindgren).

Instrumented moorings that have been deployed in the West Basin since 2014 were serviced in September of 2020 (Figure 5). Svein Vagle (Department of Fisheries and Oceans: Institute of Ocean Sciences) and Brody Granger (Bernard Laval’s Group, UBC) orchestrated the removal, downloading, reconfiguring and redeploying of several moorings. These moorings provide continuous records of water column conditions (turbidity, temperature, specific conductance) which allow the group to evaluate issues of particle resuspension and changing water column conditions in reference to overturn disturbance of bottom-stored tailings and inputs of materials into the West Basin (diffuser pipes and

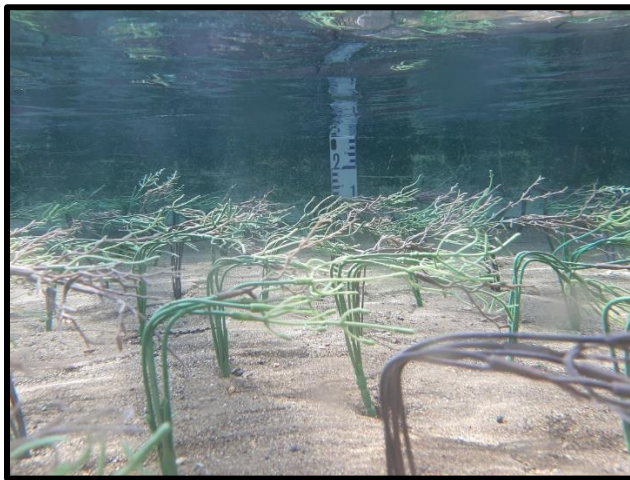
Figure 6. Underwater photo of plastic structures to represent submerged vegetation in a flume at the QRRRC. Water flow is from left to right (photo: Mahboubeh Barahimi Varnousfaderani)

Using one of the long outdoor flumes at the QRRRC, I used grass-shaped artificial flexible vegetation with different heights (Figure 6), three different non-uniform grain sizes sand for the channel bed, and styrofoam panel as a replica of ice cover. A SonTek IQ was installed to measure the approaching flow velocity, water depth and discharge during the experiment. In addition, a down-looking Acoustic Doppler Velocimeter (ADV), developed by Nortek was used to measure instantaneous three-dimensional velocity components.

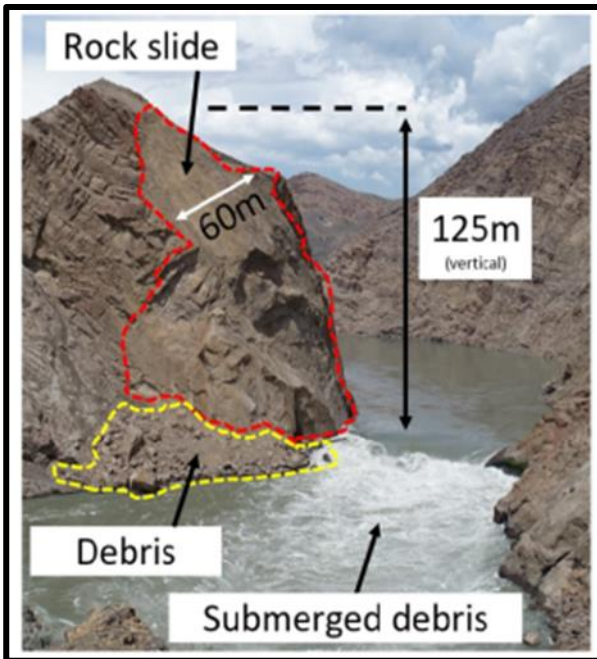
Figure 7. The Big Bar Slide (source of photo: DFO / Min. FLNRORD)

The QRRRC has found itself reprising its former role as a Department of Fisheries and Oceans (DFO) chinook salmon hatchery this year. Sometime in the winter of 2018 – 2019, approximately 85,000 m<sup>3</sup> of rock fell from a bluff 125 m above a narrow point in the Fraser Canyon near Big Bar, 50 km to the south-west of 100 Mile House (Figure 7). This event created a new 5-m-high waterfall, presenting an impassable obstacle to fish attempting to migrate upstream during high-flow conditions in the spring and early summer.
