DATE 9 February 2017**REFERENCE No.** 1662612-103-TM-Rev0-22313**TO** Luke Moger
Mount Polley Mining Corporation**CC** Don Parsons (MPMC)**FROM** Jerry Vandenberg and Michael Herrell**EMAIL** Jerry_Vandenberg@golder.com;
Michael_Herrell@golder.com**QUESNEL LAKE WATER COLOUR**

1.0 INTRODUCTION

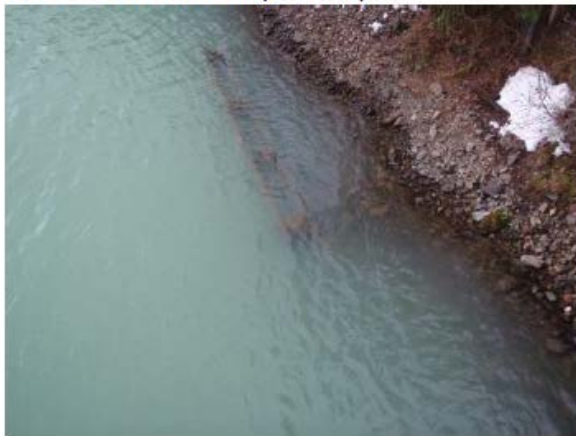
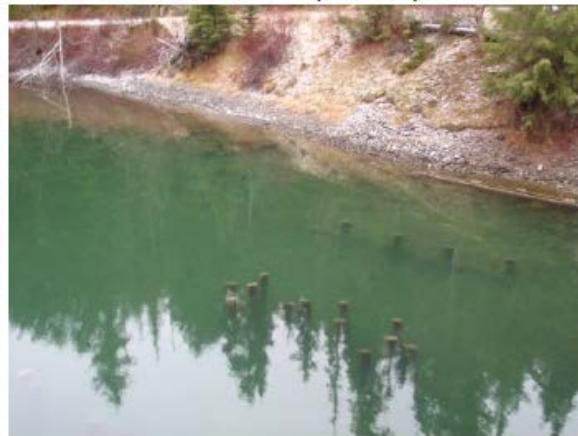
Photos 1 to 4: Green Colour Apparent in Quesnel Lake in 2014 and 2015 (MoE 2015)

Photo 3. Dec 10, 2014 (8.6 NTU)

Photo 4. Dec 10, 2015 (0.5 NTU)

The MoE memorandum noted the difference in lake colour between fall of 2014 and 2015, which is evident in Photos 1 to 4. In 2014, a temporary glacial green colour was evidently due to suspended tailings material and native till mixture that was deposited in Quesnel Lake and carried downstream during and after fall turnover, coincident with the increases in copper noted above. In the 2015 photos, the water is most green where the evergreen trees are directly reflecting off the lake surface – the outline of the trees is evident around the green section.

- *The 2014 and 2015 photo comparison shows a vast difference in colour and clarity of the water in the Quesnel River. In 2014 the colour was milky green (like glacial water) with limited visibility. In December 2015 the water appears green in the deeper part of the water but clear in the shallow foreshore. While the colour of the Quesnel River was green in late November/December of 2015, it was considerably different from the glacial green appearance of the water in the fall of 2014*

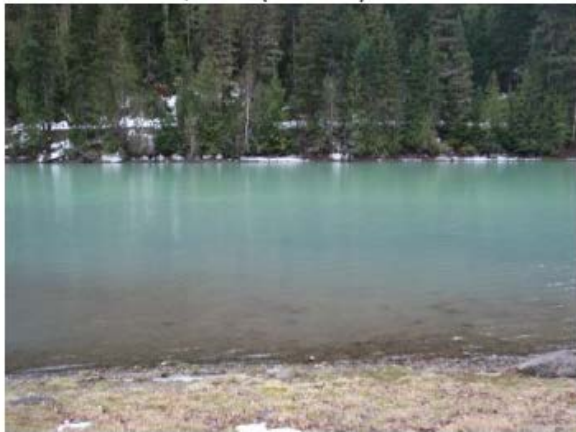
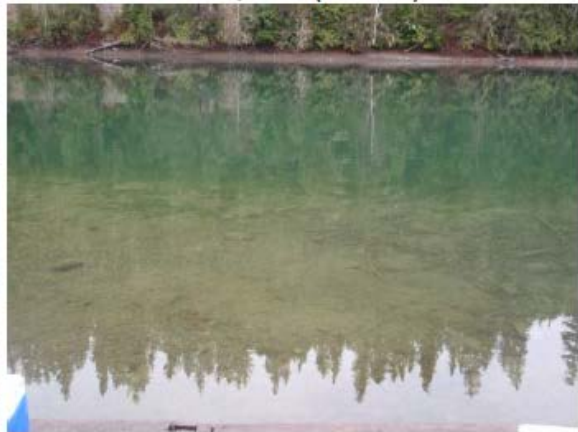
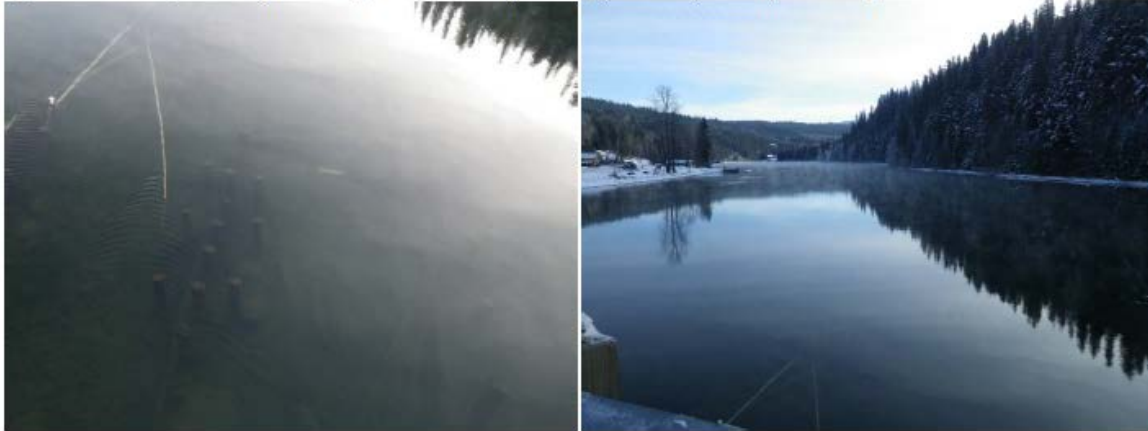
Photos 5 and 6: Two Shades of Quesnel Lake in Photos Taken at Different Angles from Same Location (from MoE 2015)

Photo 5. Dec 10, 2014 (8.6 NTU)

Photo 6. Dec 10, 2015 (0.5 NTU)

Quesnel River; taken upstream, off the Likely Bridge, Nov 25, 2015 (0.5 NTU)

The MoE memorandum also included two photos (Photos 5 and 6) that were taken from the Likely Bridge. The photos show a different shade of green in the two photos, which appears to be due to the angle of the photograph. The lake appears blue in the section where the blue sky is reflecting over the hill. The memorandum notes that turbidity in the lake during this time was “very low”, at 0.5 NTU and remained below water quality guidelines throughout the 2015 fall turnover period.

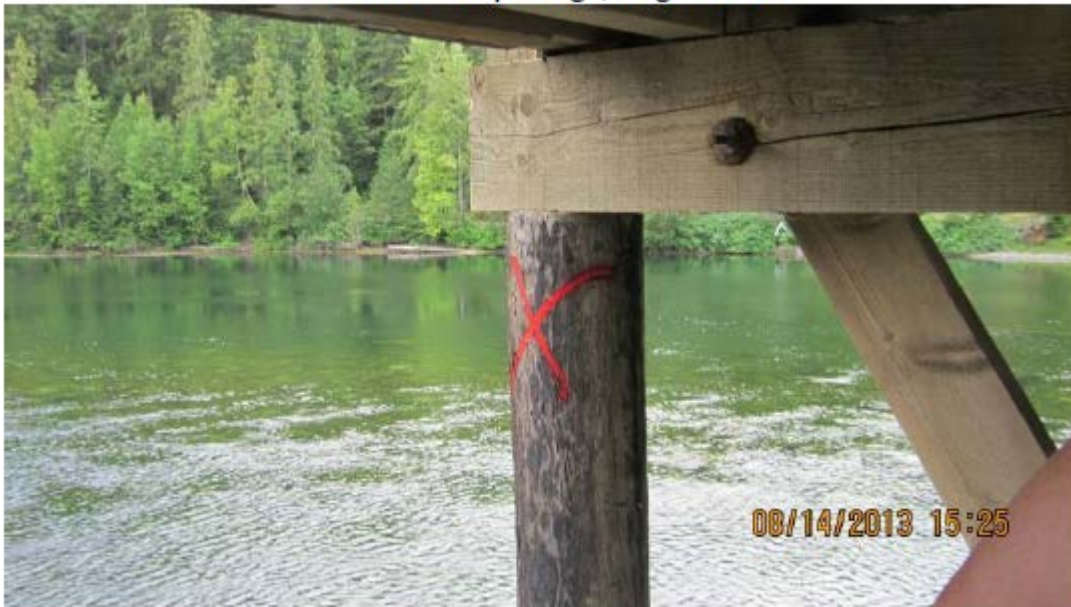
Photo 7: Quesnel Lake near Likely in August 2013 (from MoE memo)

Photo 14. Likely Bridge, August 2013

The MoE memorandum also provided photographs taken by the Ministry of Transportation before 2014. In the 2013 photograph (Photo 7), Quesnel Lake appears forest green as it reflects off the forest behind.

In summary, the green colour observed in 2015 appears most prominently in areas where it reflects the forest in the background. The green is similar in shade to the lake in 2013 and unlike the milky green that occurred in 2014.
